# Case Study

## Supporting Equipment Reliability and Engineering Improvements

### Background: Addressing Gearbox Oil Leaks

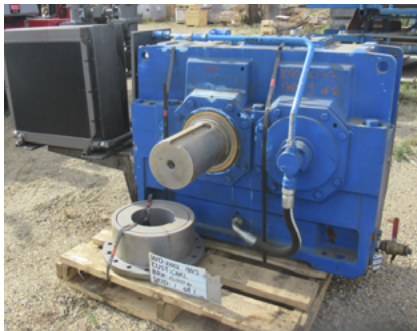
A critical pump gearbox was leaking approximately 30 liters of oil per day following a rebuild at the OEM facility. The leak originated from the output shaft shortly after startup, creating several risks:

The existing seal design on the gearbox output shaft was not sufficient to prevent oil leakage, even after a rebuild. The customer needed a solution to resolve the immediate issue and improve the gearbox's reliability for future rebuilds.

Figure 1: Gearbox as received at the Motion Repair and Services facility.

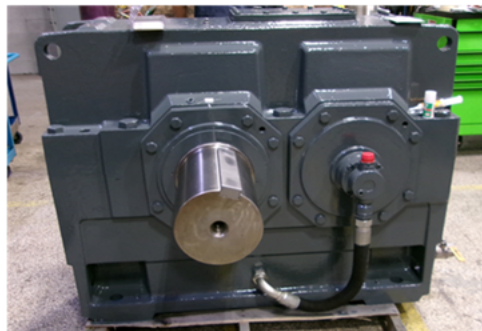
Figure 2: Gearbox after modifications and refurbishment.

- Our team collaborated with site engineers to select an improved seal design that would better withstand the gearbox's operating conditions.

- We installed the new seal design, conducted thorough testing after installation, and provided the results to the customer's site engineers for review.

The improved seal design resolved the oil leakage issue, delivering significant value to the customer. The gearbox now operates without oil leakage, reducing the risk of failure and greatly improving overall reliability. Additionally, the simplified seal design resulted in cost savings of approximately \$8,500 per gearbox rebuild. While not included in the savings calculation, eliminating the daily oil consumption further reduced operating costs. This solution has proven to be scalable, with two gearboxes already converted to the new seal design and nine more scheduled for conversion during upcoming rebuilds. The potential total value of this initiative is estimated at \$93,500, excluding the additional savings from reduced oil consumption.
