## **Road Utility Cuts and Repairs – Applying Keyhole Technology**

Michael L.J. Maher, Principal, Golder Associates Ltd., Whitby, Ontario

Paper prepared for presentation  
at the **Better, Faster, Safer Road Maintenance** Session  
of the 2013 Conference of the  
Transportation Association of Canada  
Winnipeg, Manitoba

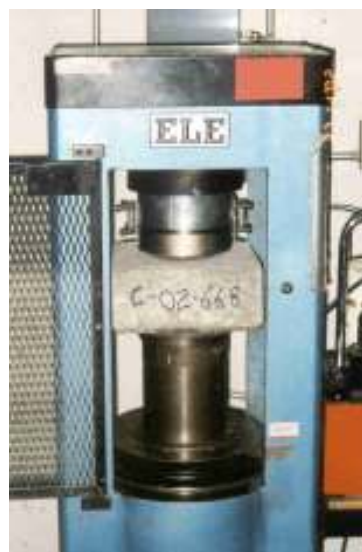
Figure 2 – Test set-up for simulated keyhole testing

Initially, some 15 different commercially available grouts and bonding compounds were evaluated on a preliminary basis. The workability, early strength gain and ease of site mixing were used to shortlist five products for laboratory testing. The bonding compounds were evaluated based on compressive strength at various ages (ASTM C109) and using a specially devised punching shear laboratory test that was designed to simulate to some degree the loading conditions in the field. The test arrangement for this laboratory test is illustrated in Figure 2.

A nominal 100 mm diameter core was cut from concrete slabs 250 mm square by 100 mm thick. The slabs were made from 30 MPa concrete. The cores were bonded back in place using the bonding compound product selected for laboratory testing. The load needed to dislodge the core was measured at various ages. From this study, an epoxy-type bonding compound was initially selected. Based on further discussions with the client, it was decided that this product would be impractical for large-scale use in the field and had some health-related concerns for field crews.

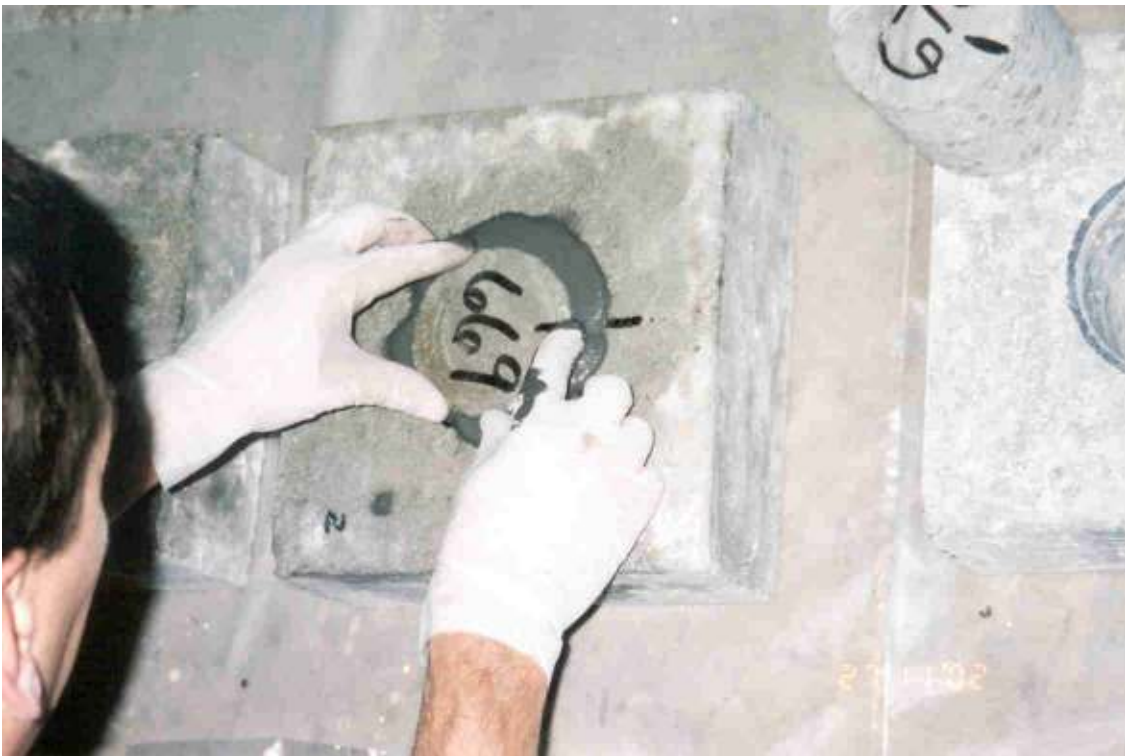
Figure 4 – Core sample being re-instated into slab for push-out testing

As in the previous phases of the laboratory evaluation, the punching shear laboratory tests, or push-out tests, were used to simulate loading conditions in the field. The cores were bonded back in place using the bonding agent being assessed. The test arrangement was designed to determine the load needed to fail the shear bond at the core/core hole interface and dislodge the core. The failure load was recorded over a range of curing times from 1.5 to 48 hours. In many instances, especially at higher failure loads, the concrete test slabs cracked as the core was punched through, indicating that the bond was stronger than the overall concrete substrate.

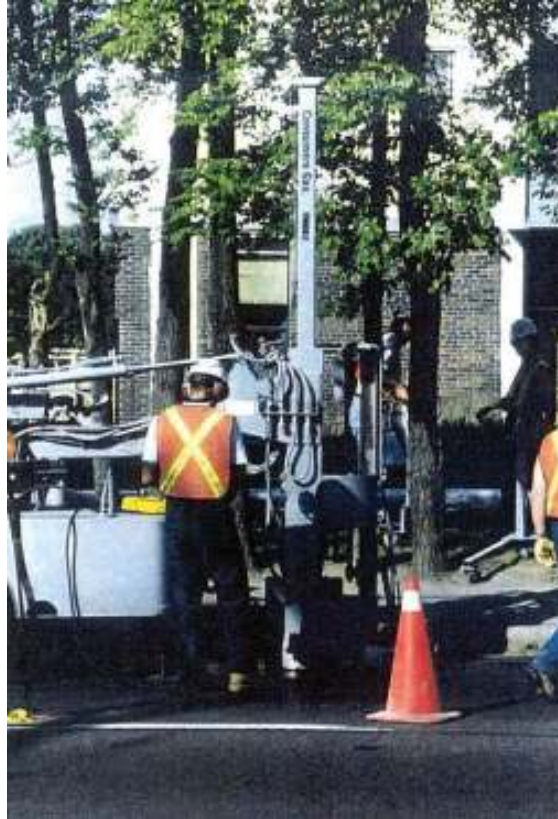
Figure 8 - View of coring rig at 720 Kennedy Road in 1995

One of those bus route locations was at 720 Kennedy Road where an excavation, repair and core reinstatement was undertaken in August 1995. Kennedy Road (Figure 8) is a major arterial road in the City with four lanes of traffic and an AADT in excess of 10,000 vehicles in each direction. It is also a major bus route for the TTC with an average of 380 southbound bus trips per week.

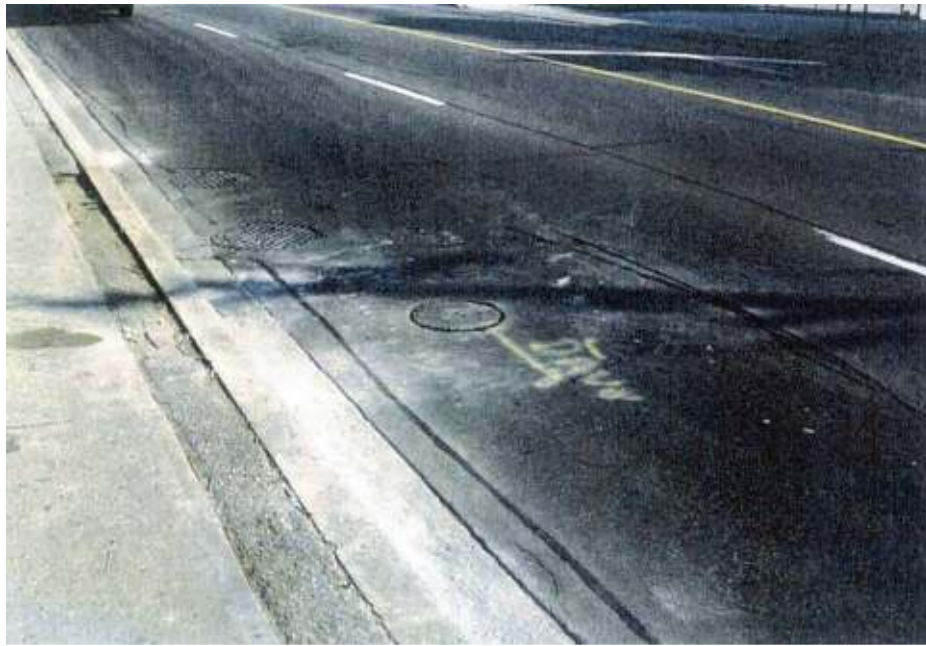
Figure 10 – View of reinstatement two weeks after installation

Two weeks after the reinstatement, the site was revisited and the core restoration inspected. Figure 10 and Figure 11 show the appearance of the core after sustaining two weeks of traffic comprising approximately 70,000 vehicles, including 760 bus passes.

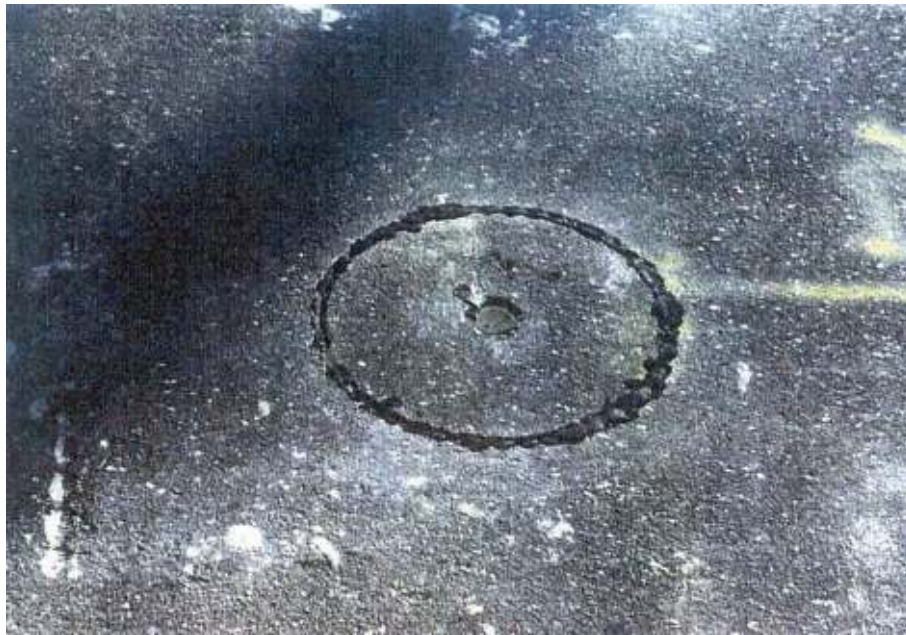
Figure 11 – Close-up view of reinstatement two weeks after installation

Figure 11 also confirms an excellent continuous bond within the asphalt surface layer. Crack sealing compound had been used around the surface joint. What was also encouraging was the complete infilling of the voids in the pea gravel bedding showing complete contact between the base of the core and the supporting stabilized pea gravel.

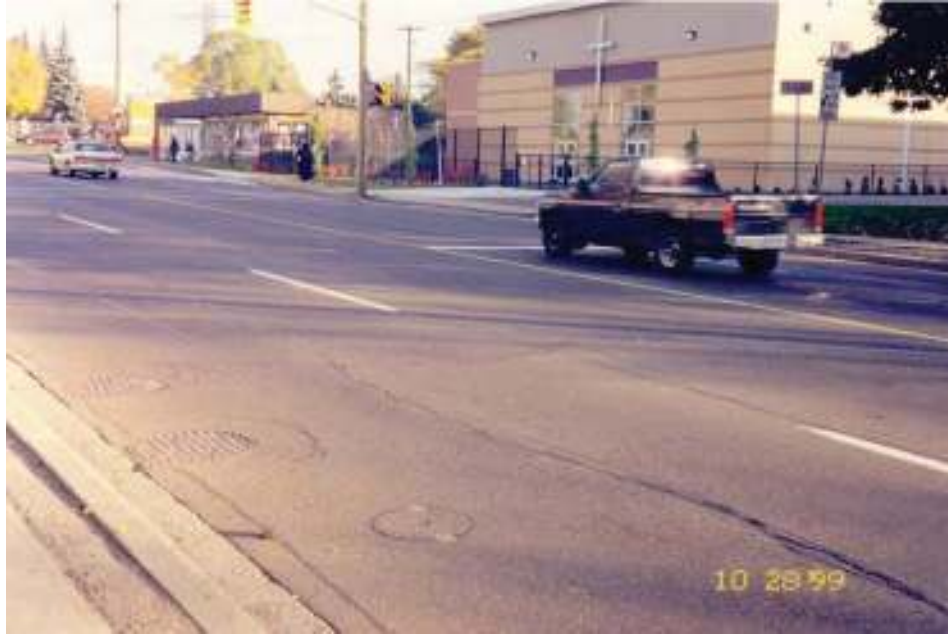
Figure 13 – Kennedy Road four years after reinstatement

Four years later in October 1999, the photographs shown on Figure 13 and Figure 14 were taken and confirmed no displacement of the reinstated core and no associated degradation of the pavement surface.

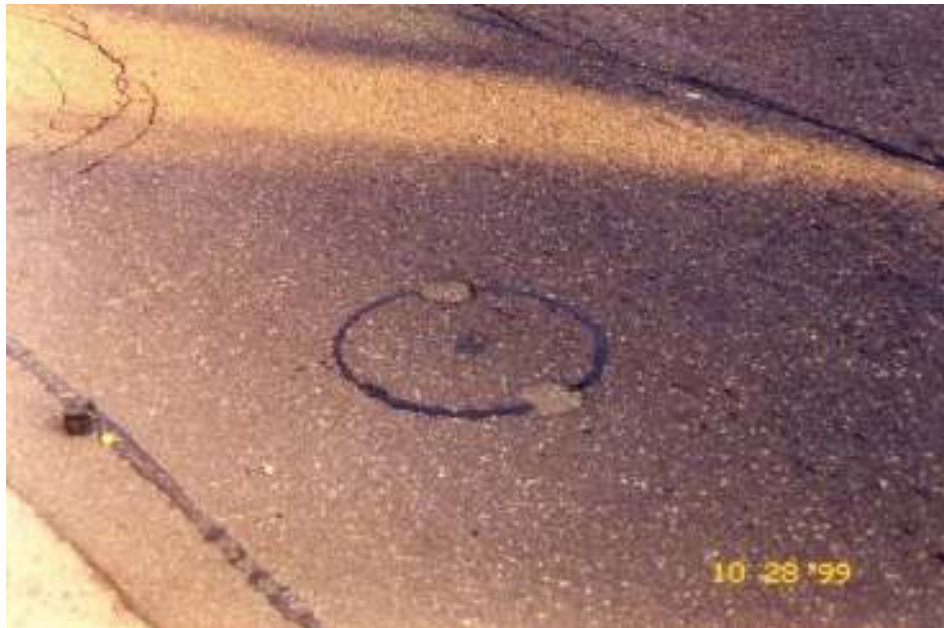
Figure 14 – Close-up view of core on Kennedy Road four years after reinstatement

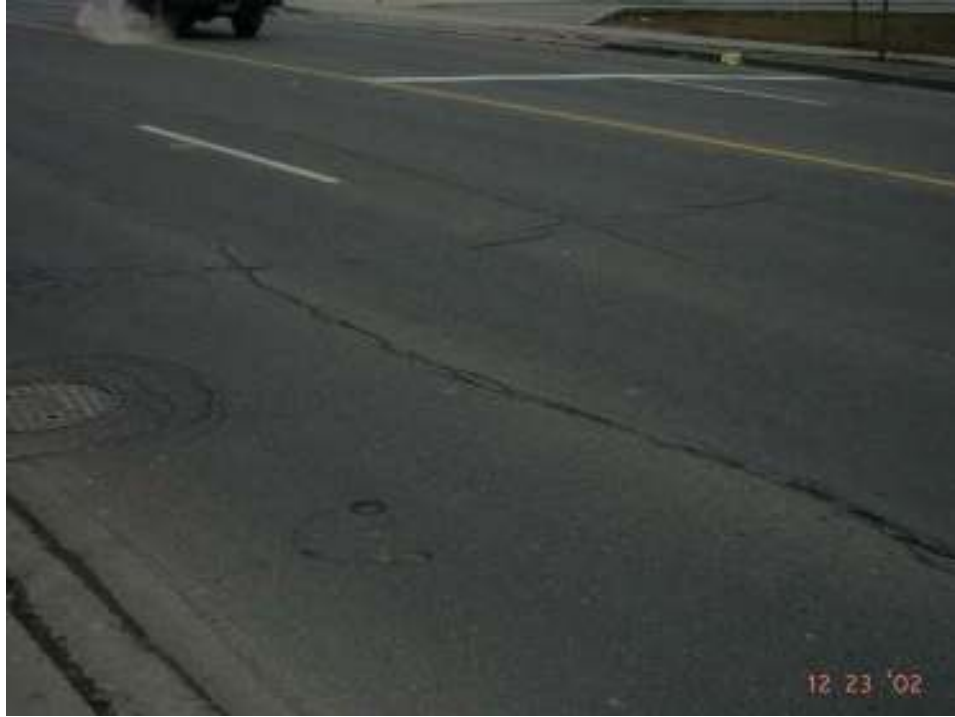
Figure 15 – Kennedy Road Keyhole Core, over seven years after reinstatement (Dec. 2002)

The core reinstatement was again inspected in December 2002, some seven years and four months after the reinstatement.

By December 2002, it was estimated that the reinstated keyhole core had withstood more than 145,000 transit buses and more than 13 million commercial and other vehicle passes.

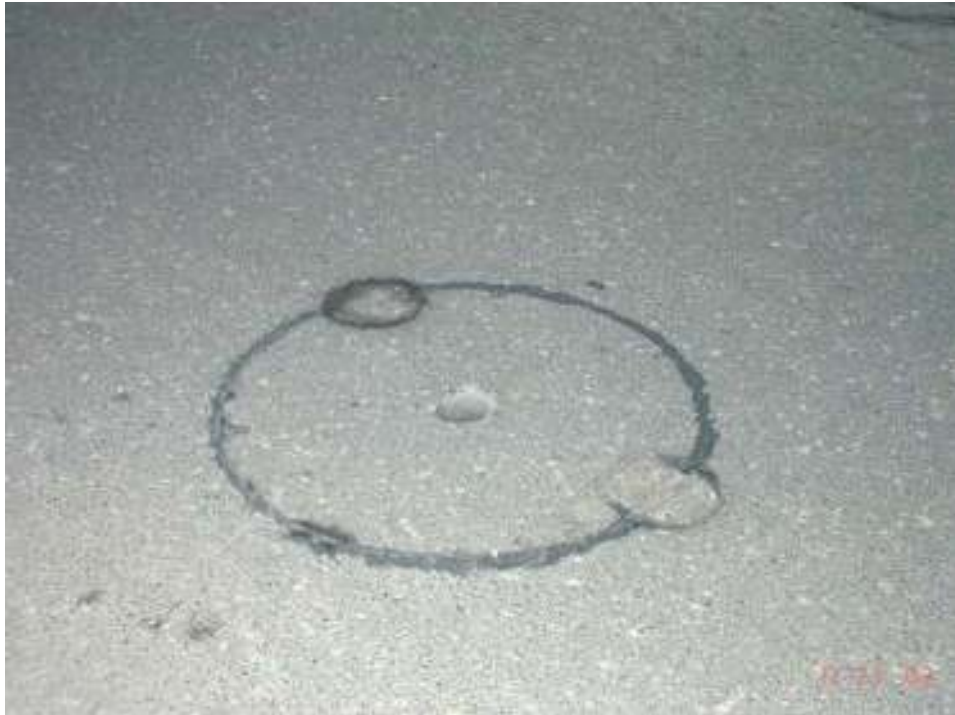
Figure 16 – Close-up view of Kennedy Road test core (Dec. 2002)
